# GOTHIC REVIVAL

A library at the University of Michigan was dark and dismal before a lighting renovation brought back its grandeur

### University of Michigan Cook Legal Research Library Reading Room

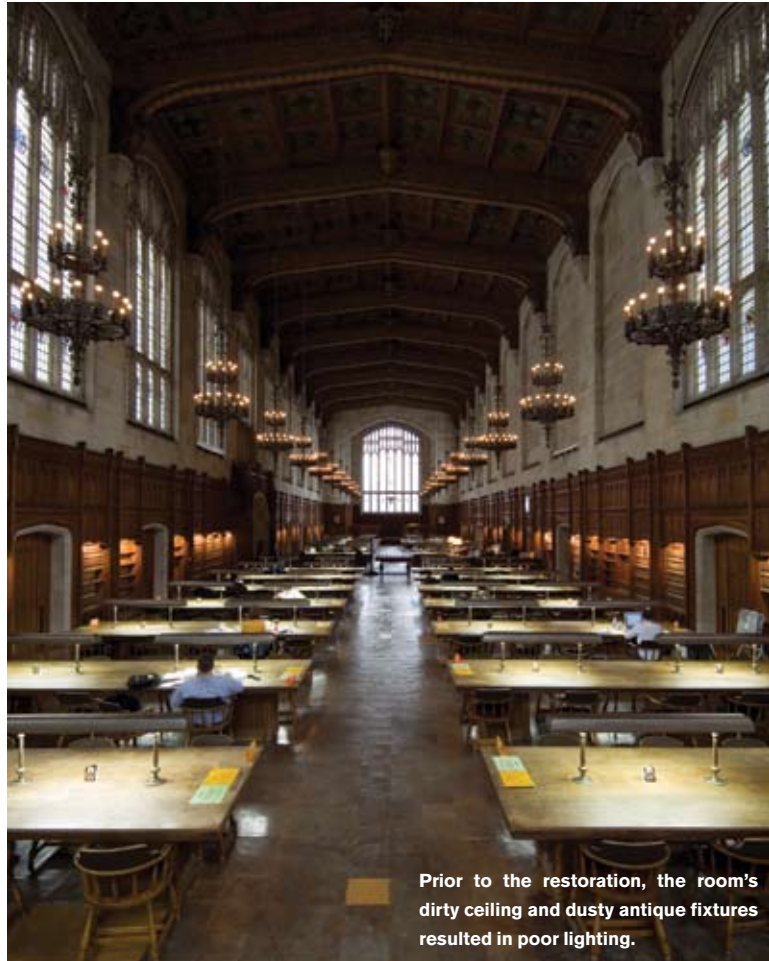
Prior to the restoration, the room's dirty ceiling and dusty antique fixtures resulted in poor lighting.

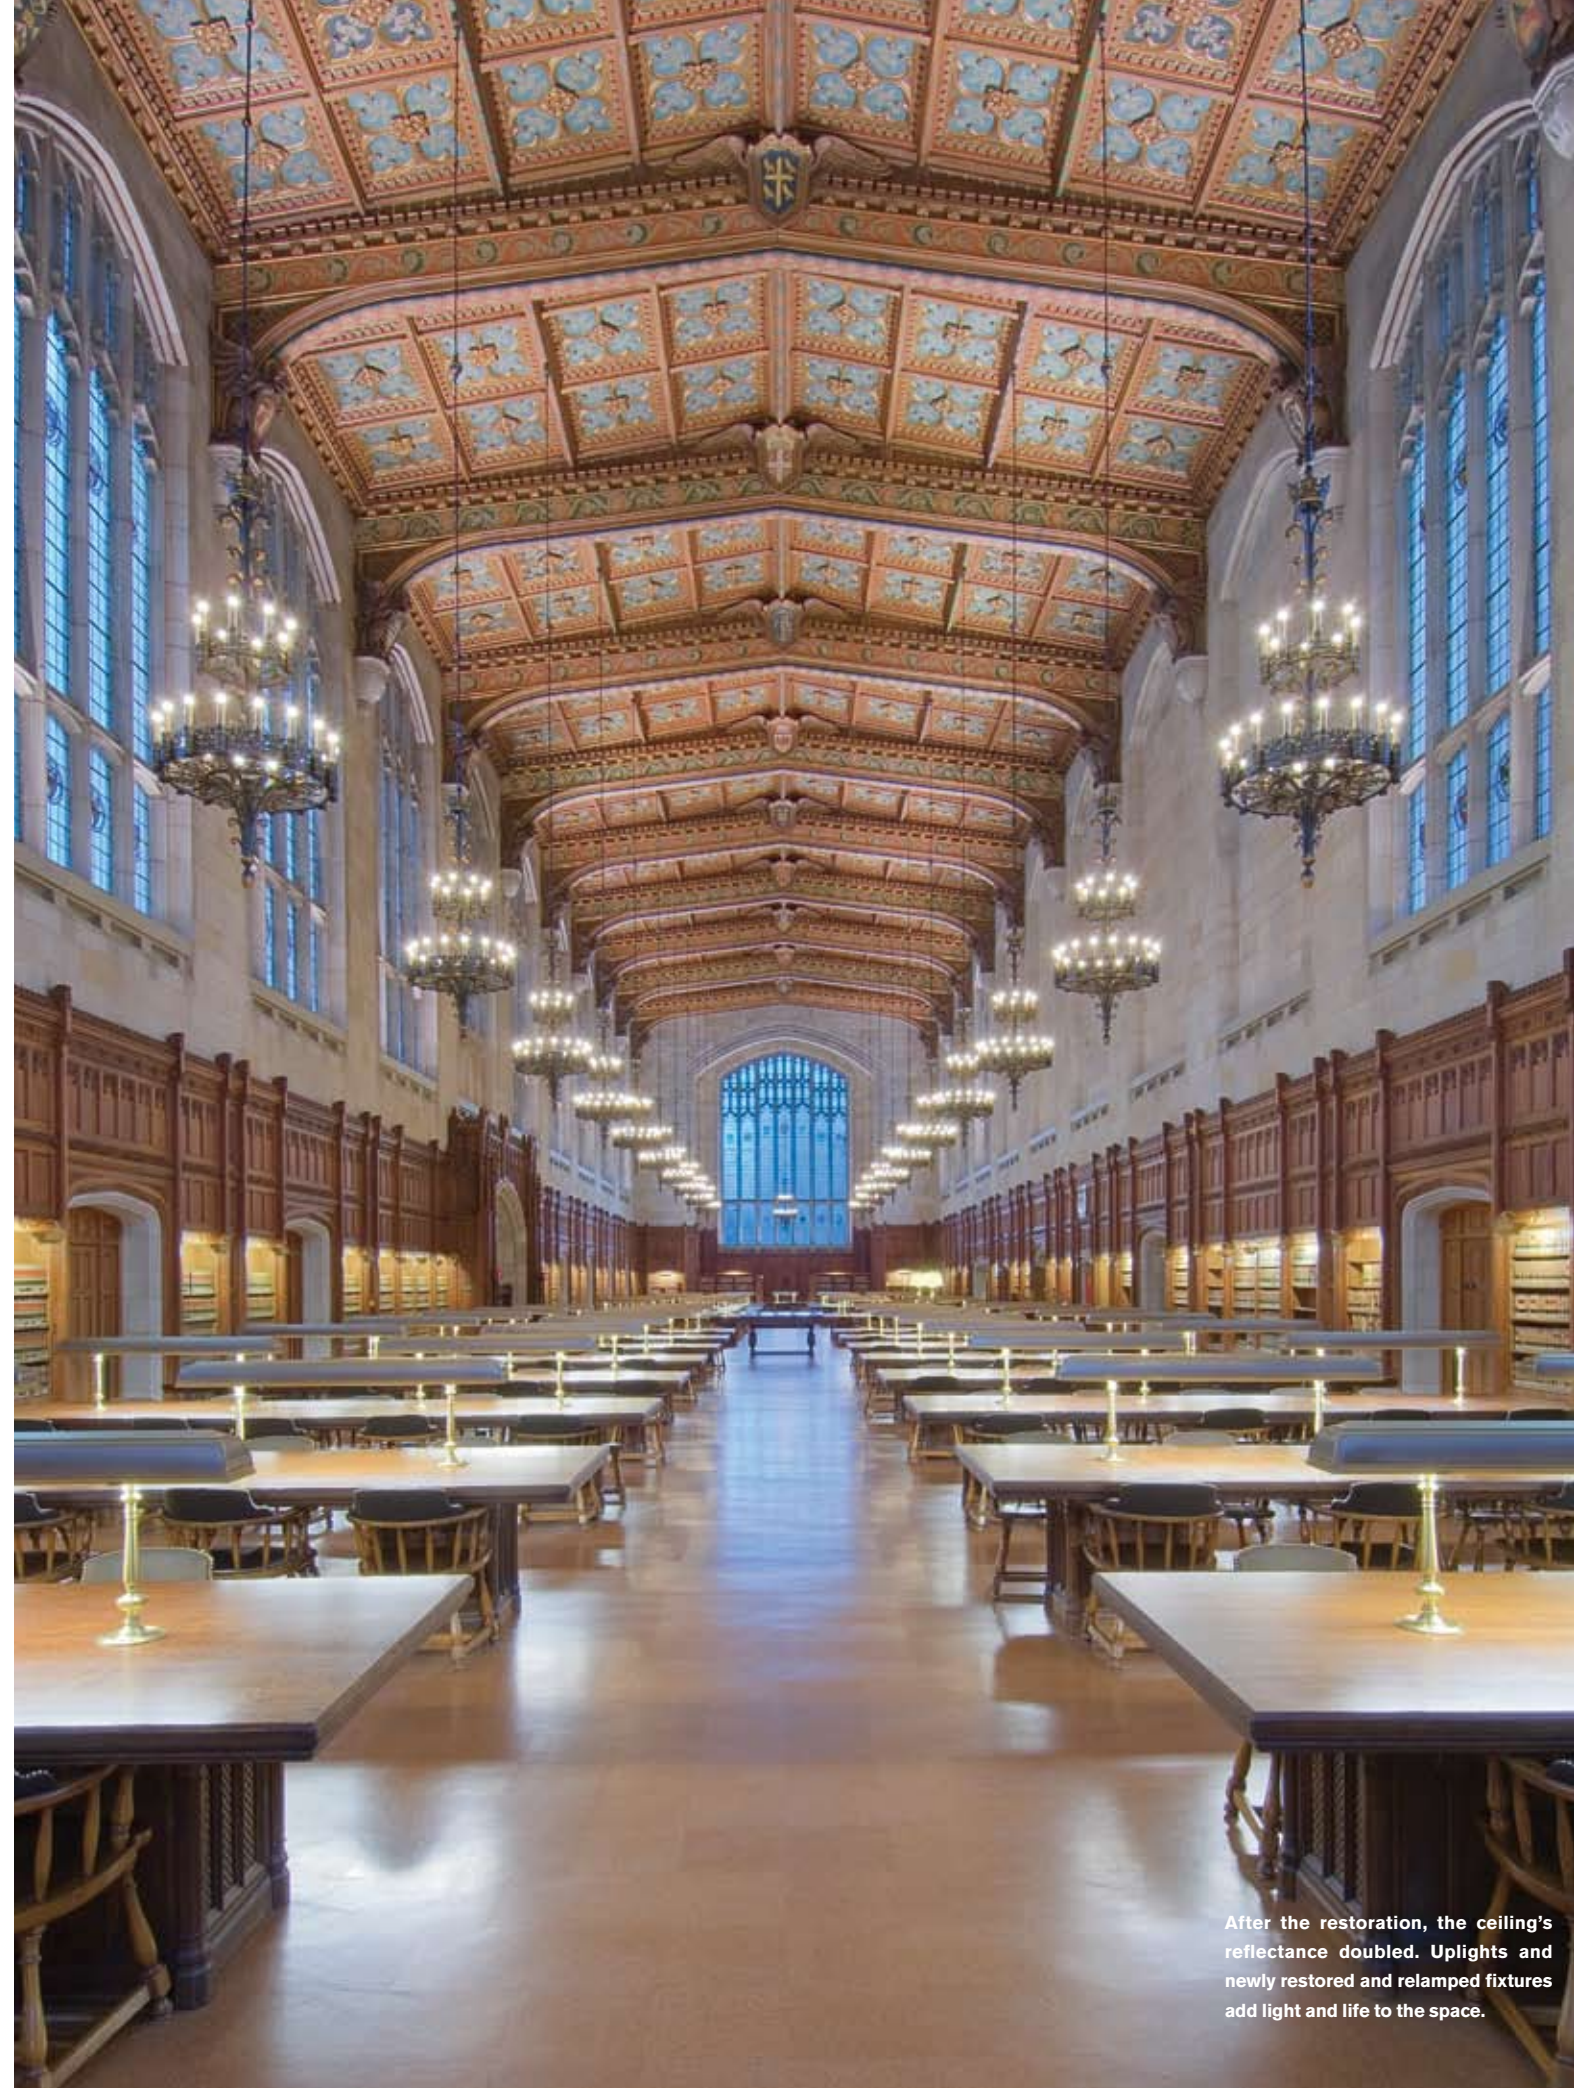
After the restoration, the ceiling's reflectance doubled. Uplights and newly restored and relamped fixtures add light and life to the space.

The first step of the restoration was cleaning. To clean the ceiling without damaging sensitive paints and finishes, the conservator worked with a solution made from 5 percent citric acid and de-ionized water, often used in fine art restoration. After the cleaning was complete, the ceiling's composition was revealed. Though it “resembles a large timber roof structure,” says Yallop, it is actually made of plaster with faux-painted details. The team also found that their estimations about the reflectance had been correct; it had doubled from the cleaning.

To provide “a significant punch of light given the distance of throw from the sills to the ceiling,” Steffy looked for a lamp with 3,000K color temperature, more than 80 CRI and a relatively long lamp life, which “pushed us right to ceramic metal halide.” The uplights pair 39-W PAR20 CMH lamps (GE) with theater footlights from RSA Lighting to achieve the desired punch. After several mock-ups, the lights were installed and the ceiling transformation was complete.

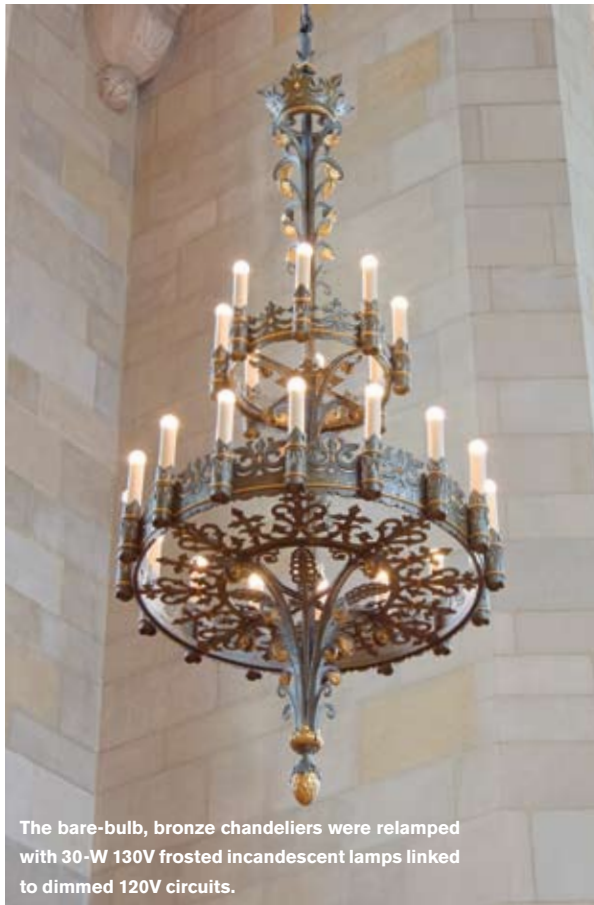
The bare-bulb, bronze chandeliers were relamped with 30-W 130V frosted incandescent lamps linked to dimmed 120V circuits.

**Chandeliers:** When they arrived at the factory, the 24 bare-bulb, Gothic-style, bronze chandeliers were covered with “an enormous amount of dust, which had made a layer about ½-in. thick that was almost like carpeting,” notes Stefan Morikawa, principal, Crenshaw. Using a pH-neutral solution, Morikawa and his team rid the fixture of its coating. Underneath, they discovered gold-leaf highlights that had been hidden by dust and a unique Swedish iron-style finish over the bronze base. The highlights were retouched by hand, after which a UV-inhibiting lacquer and a clear top coat were applied for protection. Additionally, the fixtures underwent asbestos abatement and were rewired to UL and CSA standards.

a problem when looking for an alternate source. “As of when we specified the project in late 2007, there were no close equivalents to incandescent lamps for a bare lamp situation. LEDs and CFLs were just not there yet,” says Steffy. To maintain the original look while cutting down on the energy output, 30-W 130V frosted incandescent lamps (GE) are linked to dimmed 120V circuits for a connected load of 15 watts each. With the dimming, the lamps now have close to a 20,000-hour life, significantly reducing maintenance time and cost.

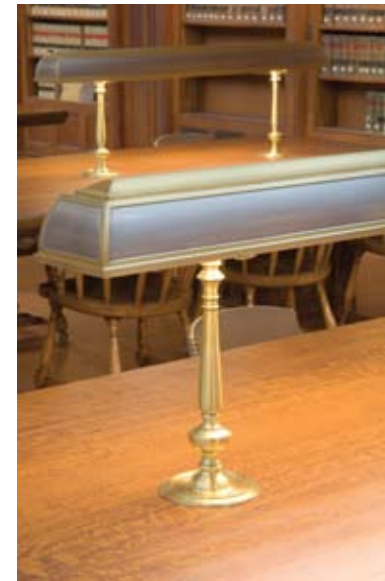
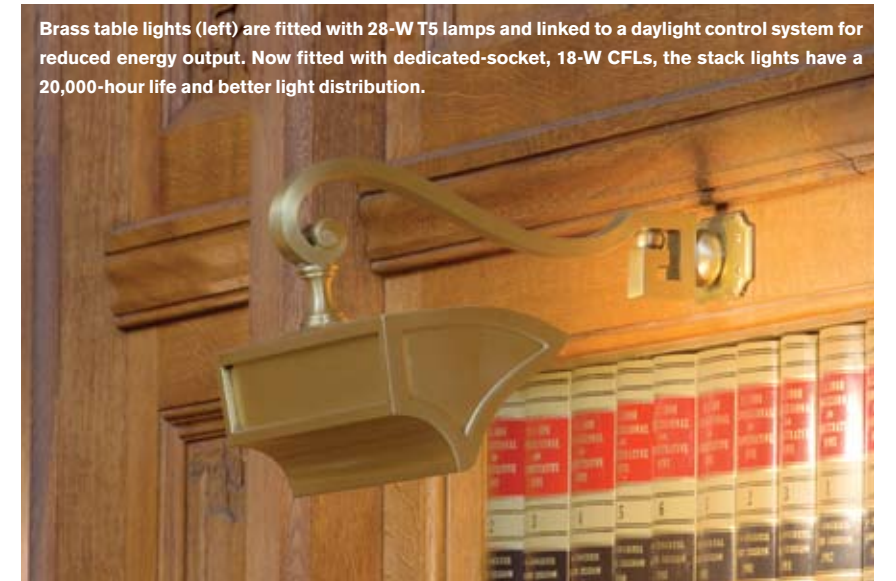
Brass table lights (left) are fitted with 28-W T5 lamps and linked to a daylight control system for reduced energy output. Now fitted with dedicated-socket, 18-W CFLs, the stack lights have a 20,000-hour life and better light distribution.

While eye-catching, the luminaires “are so close to the tables that they were over-lighting them,” says Steffy. Originally incandescent, the table lights were retrofitted in the 1950s with T12 lamps. Such efficiency contributed to the room’s luminance imbalance and, by today’s standards, the T12s consumed unnecessary energy. Replacing the T12s are energy-efficient 28-W T5s (Philips), which reduce light output. The new lamps also use a step dimming ballast on photocell that allows them to operate at 50 percent output with sufficient daylighting. The T5s “improve uniformity of light on the tables and reduce the overall light levels,” says Steffy.

Steffy opted to swap the University-retrofitted, screw-base CFLs—which had replaced the original incandescents—with dedicated-socket, 18-W CFLs. The new CFLs have a longer life—20,000 hours—and “better efficiency of distributing light down the stacks,” says Steffy. Crenshaw fitted the fixtures with electronic ballasts to accommodate the new lamps, but kept the original optics intact.

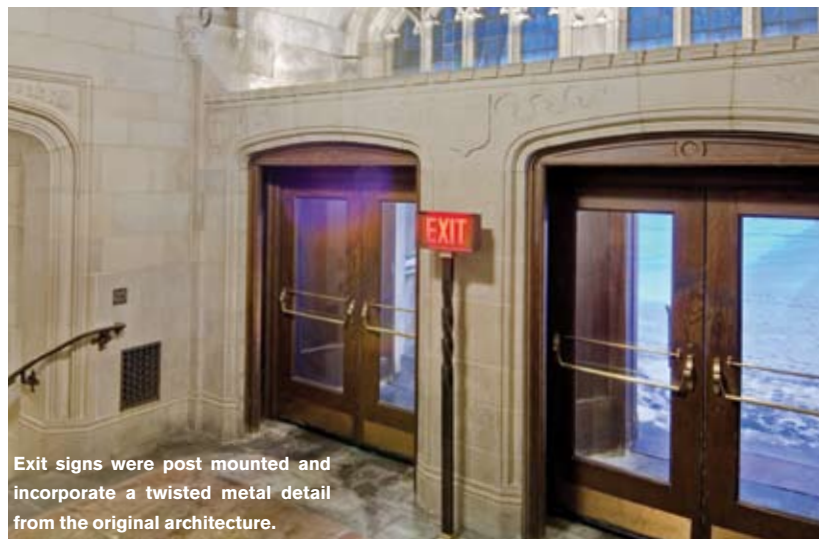
Exit signs were post mounted and incorporate a twisted metal detail from the original architecture.

od-era-styled exit signs “were mounted on a decorative post that incorporated a twist in the middle,” explains Yallop. “We used subtle cues from the reading room to design the frame around the sign,” keeping the character of the space, while meeting code. Like the rest of the design, they bring the room’s rich history to life.
